WRECKAGE AND IMPACT

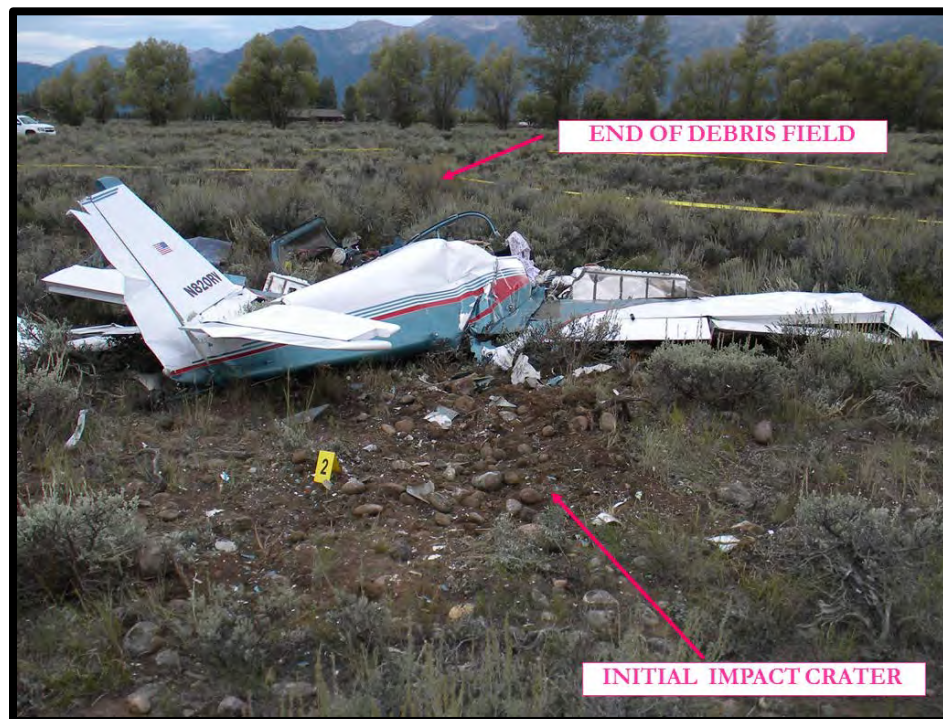
Figure 1: Accident Site Debris Field

The accident site was located on adjacent to the airport's perimeter, with the debris stretching over 200 feet from the first impact marking to the farthest debris found (balance weight from the upper vertical stabilizer); the main wreckage was situated immediately after the initial impact crater. In character, the flat terrain was comprised of hard dirt and rocks, populated by brush typical of the eastern Wyoming region. The global positioning satellite (GPS) coordinates for the main wreckage were approximately 43.590556 degrees north latitude and -110.743333 degrees west longitude, at an elevation of about 6,400 feet mean sea level (msl).

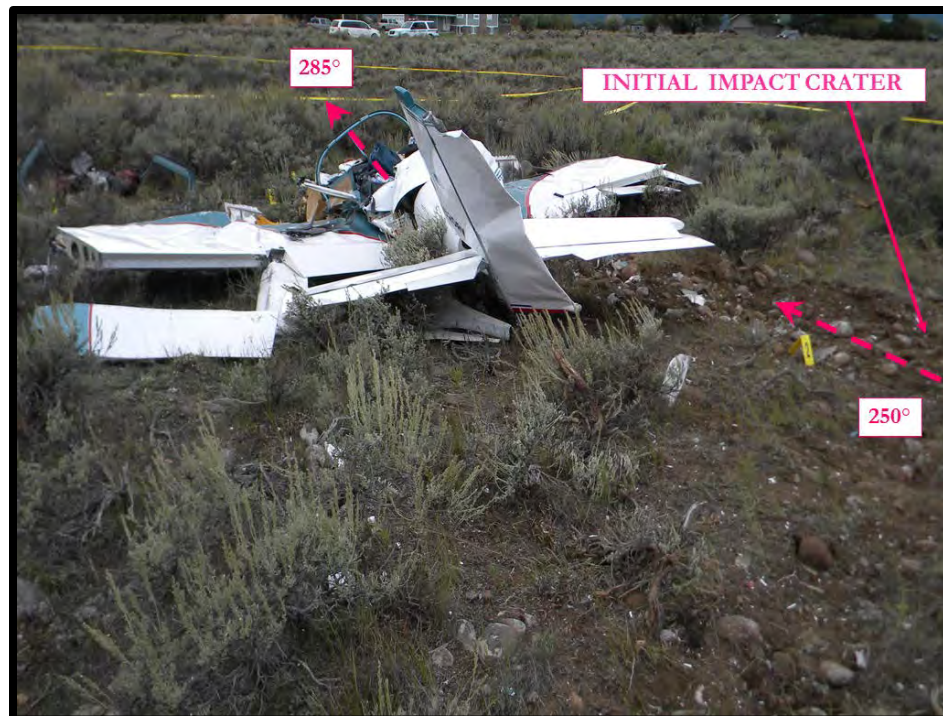
Figure 2: Main Wreckage

The main wreckage came to rest on a with the nose on a heading of about 285 degrees and the majority of the crush damage was to the engine and cockpit section with the empennage and tail section sustaining the lesser damage. The main wreckage consisted of the major airframe components and the engine; the propeller, canopy and top portion of the cowling were found further down from the debris field.

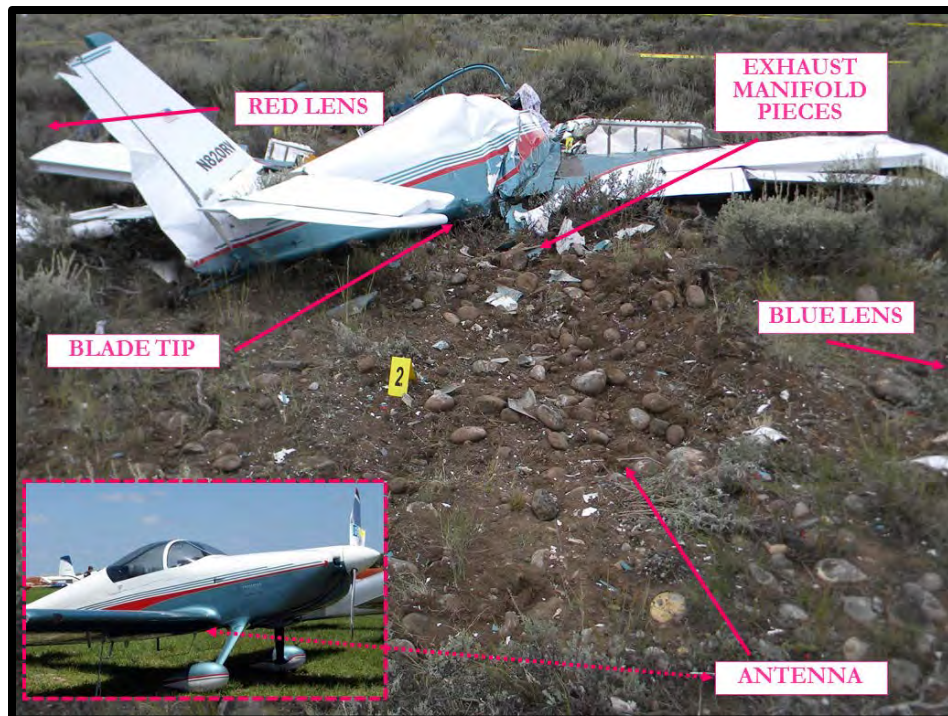
Figure 3: First Identified Point of Impact

The first identified point of impact consisted of a crater about five feet long and four feet in diameter, where engine pieces and composite fragments were imbedded in the compacted and disrupted dirt. The main wreckage was located about five feet from the initial crater with an overall energy path of about 250 degrees. Located in the crater was the communication antennas that would normally be situated on the front underbelly; just forward of that were pieces of the exhaust manifold (which were 13 feet aft of where the engine came to rest).

There were two similar elongated areas of disrupted dirt that were perpendicular to the main impact crater of the first impact point. The right disrupted dirt area measured about 11 feet from the initial impact crater and small fragments of green/blue lens were located at the end (about 12 feet aft of where the lens housing and right wing had to come to rest). The left impact elongated depression measured about 12 feet in length. Red lens fragments were found adjacent to that area the wing tip would normally be situated at the end of the outboard left-wing leading edge. The depressions were consistent in size and orientation to that of the wings, which each measured about 10 feet and 3 inches.

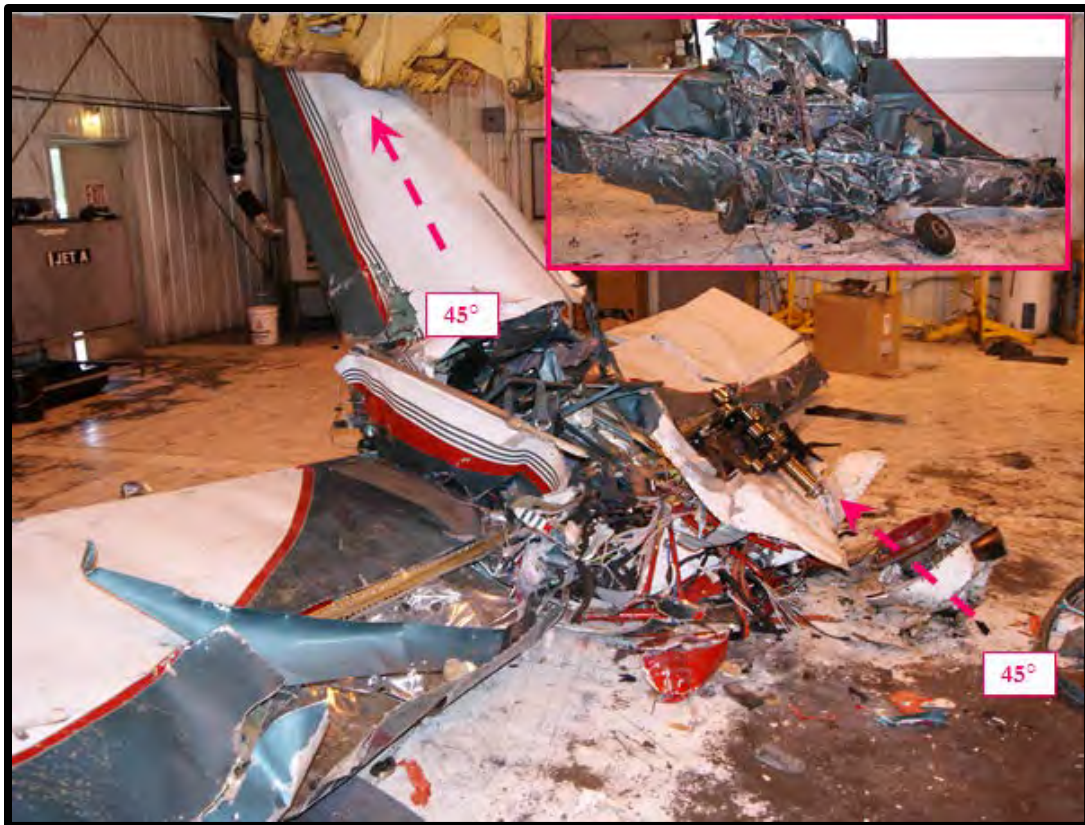
Figure 4: Fuselage Crush Angle

The cockpit area sustained major crush damage to the forward section and the right and left fuselage sides showed the near 45° angle crush angles aft of the cockpit area. The fuselage sustained crush damage to the left side and was accordion against the left wing. The left wing tip located about 2 ft from the left wing; the flap was attached on the inboard section and had come detached from the control rod on the outboard section. The left aileron was attached on the inboard control arm.

The right side fuselage adjacent to the wings had sustained crush damage and was accordianed backward in about 45 degree crush angle. The right flap was attached to his respective hinges and ailerons outboard section had become free of the control rod. The inboard side of the right-wing leading-edge had come forward and was detached off the rivet line consistent with full fuel tanks.
